3M ESPE

Making Better Impressions

Guide

A Troubleshooting Guide

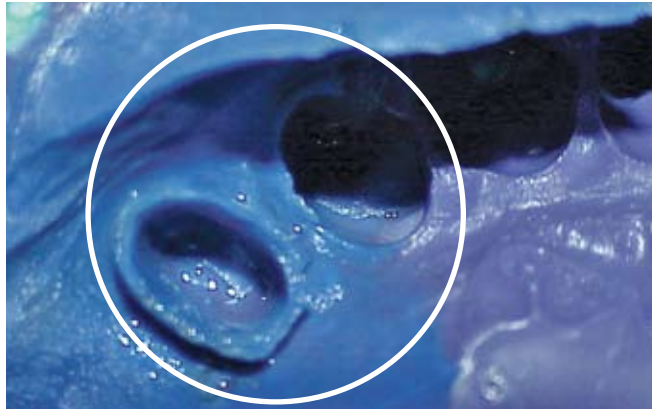
Visual Appearance: Impression not completely set. Shiny, no detail of site.

Result: Inadequate surface detail on stone cast, poor fitting restorations.

Sulfur inhibition due to contact of latex gloves with tissue/tooth/retraction material or impression material.

Residues from custom temporary or provisional cements (acrylics) present.

Inhibited Setting

Wear gloves proven not to contain traces of sulfur.

If contamination is suspected, scrub affected area with diluted hydrogen peroxide.

Do not use impressions already used to fabricate the temporary restoration.

Fabricate the temporary crown or bridge after final impression has been made.

Remove air-inhibited layer on the exposed surface with an alcohol wipe before making final impression.

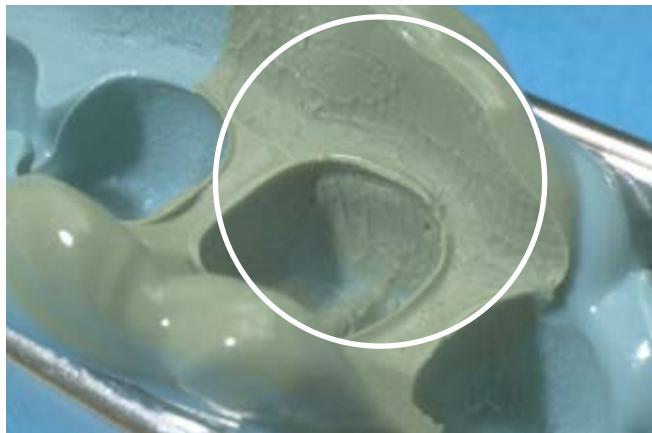
Surface Inhibition

Substances with pH < 4 inhibit setting reaction, most commonly by the contact with acidic retraction materials and hemostatic agents containing epinephrine or ferric sulfates.

Use retraction materials having pH ≥ 4 .

Select retraction materials and hemostatic agents not containing these chemicals.

Rinse, remove, dilute hemostatic solution with water spray and suction. Dry before taking the impression.

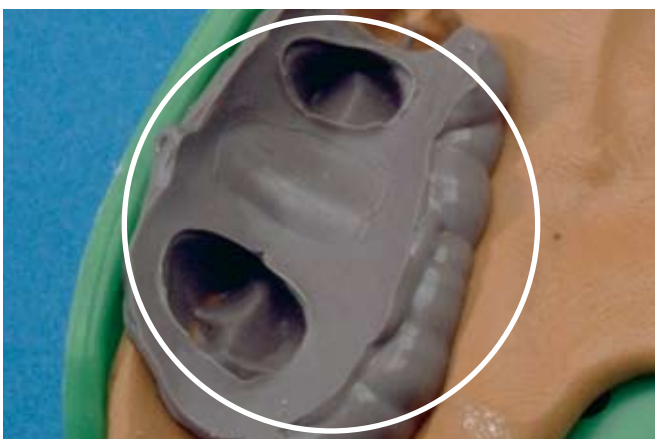
Exceeding the Working Time

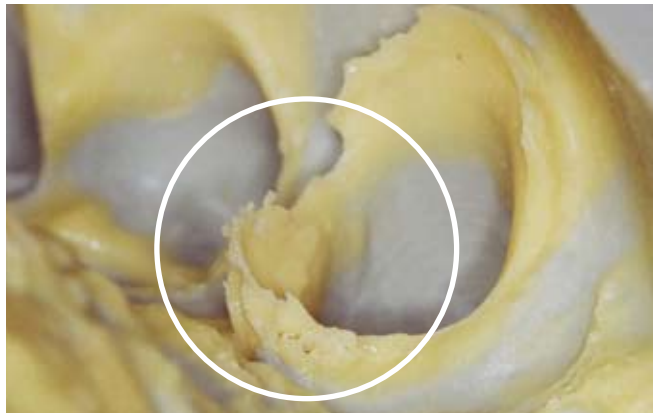
Visual Appearance: Rip, or visible tearing on the margin of the preparation.

Result: Short crown margins and/or open margins.

CAUSE	SOLUTION
Expired impression material.	Check expiration date of impression material.
Inadequate mix.	Bleed before applying mix tip to ensure even dispensing. Use proper mix tip. Ensure mixing instructions are followed and materials have a streak-free appearance.
Insufficient retraction.	Displace tissue to allow the impression material to access prepared area. Consider two-cord retraction. Leave pilot cord in the sulcus when taking the impression. Use impression material with sufficient tear resistance.

Poor Retraction — Insufficient Tear Resistance

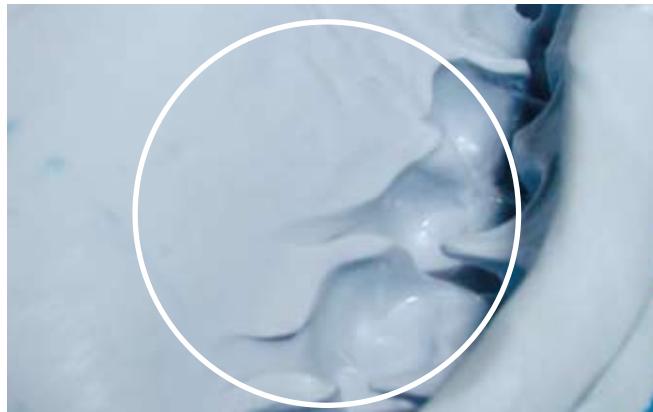
Visual Appearance: V-shaped void, trough-like.

Result: Failure to capture complete and accurate dentition.

CAUSE	SOLUTION
Exceeding the working time.	Follow manufacturer's working time specifications. Choose material with longer working time.
Tray movement or repositioning after seating.	Do not move tray after seating.
Insufficient amount of impression material used.	Use more material to create back flow effect.
Impression tray does not support flow of impression material.	Use lingual stops. Use an impression tray that supports the flow of the material.

Lingual Pulls

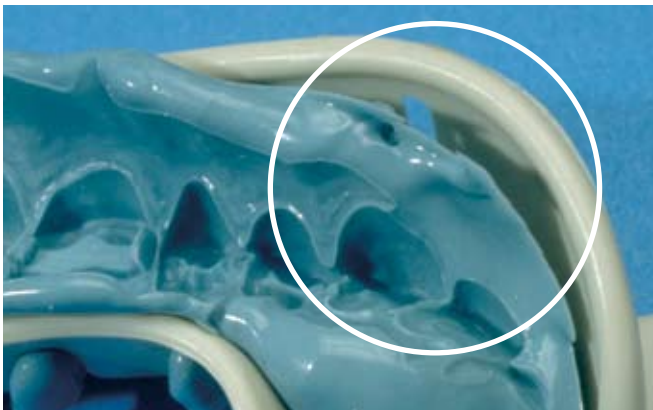
Visual Appearance: Impression pulling away from the sides/bottom of tray.

Result: Crown(s) may be tight and not seat fully, or require excessive internal adjustment.

CAUSE	SOLUTION
No tray adhesive used.	Use tray adhesive.
Incompatible tray adhesive used.	Use appropriate tray adhesive. VPS adhesive for VPS. Polyether adhesive for polyether materials.
Inadequate drying time for tray adhesive.	Follow manufacturer's instructions for application, and drying time.
Thin plastic trays allow deflection, which can cause rebound upon removal.	Use a tray that fits better, and is stiffer and more rigid.

Separation of Material from Tray
